**SITE INSPECTION REPORT  
THE CLOROX COMPANY OF PR  
CAGUAS, PUERTO RICO**

CERCLIS ID No.: PRD090473398

August 10, 2006

**PUERTO RICO ENVIRONMENTAL QUALITY BOARD  
EMERGENCY RESPONSE AND SUPERFUND PROGRAM  
SUPERFUND PA/SI DIVISION  
SAN JUAN, PUERTO RICO 00926**

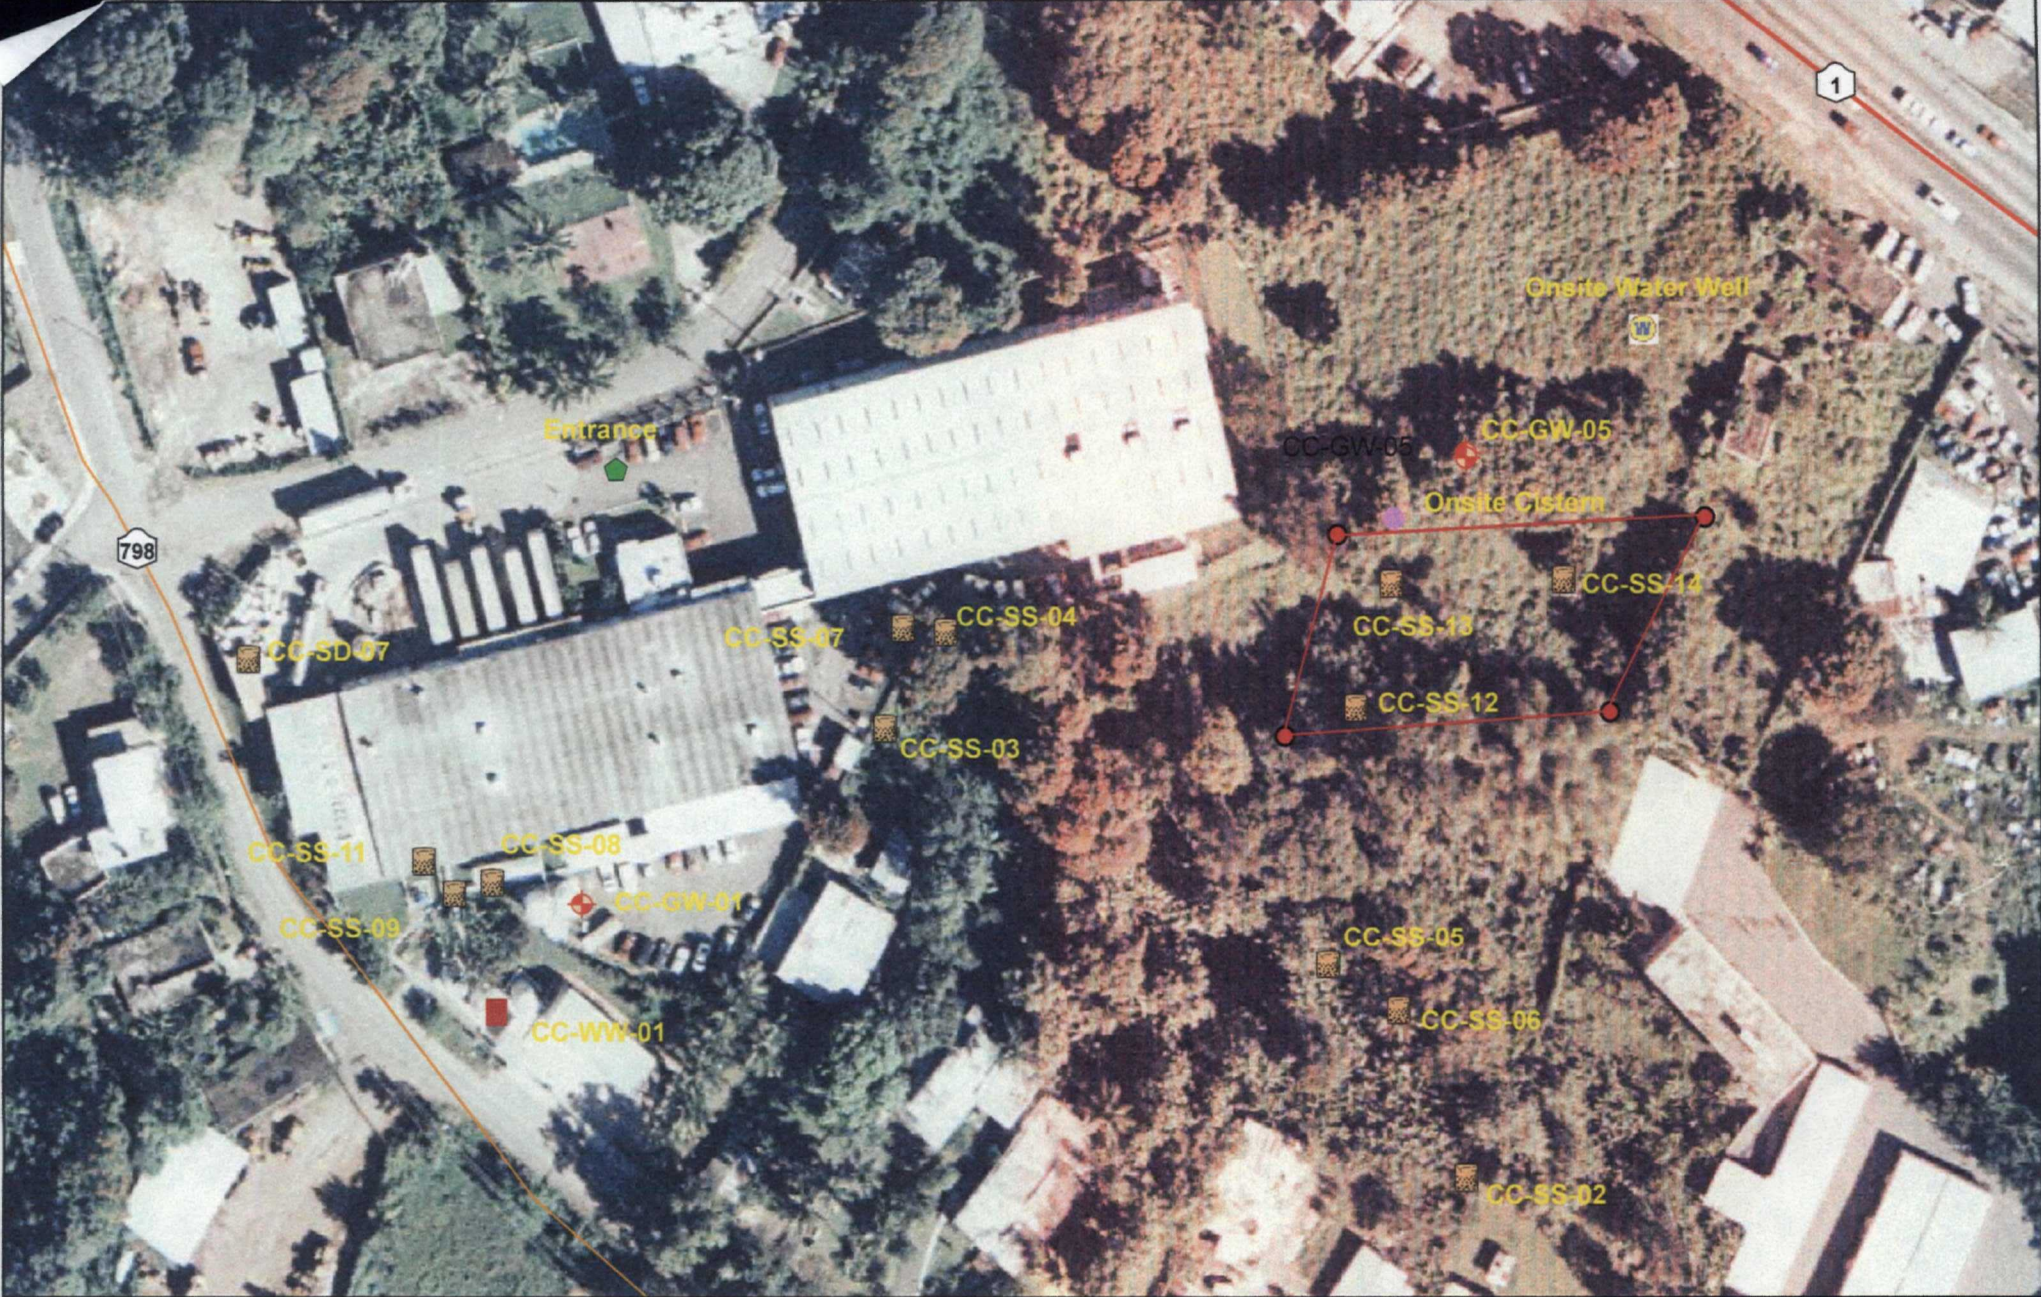
# FIGURE 4

The results indicated the presence of Aroclor-1260 at concentrations of **180 µg/mg in sediment sample** (SD-04) collected at the PPE #2 (See Figure 3). This contaminant was found in one of the surface soil samples collected during the sampling activities performed from March 7-14, 2006.
